**Huber  
Environmental  
Consulting Inc.**

Water Quality  
Study  
of the  
Bayfield River  
Downstream  
of the  
Municipality of Bluewater's  
Bayfield  
Sewage Treatment Facility

September 2011

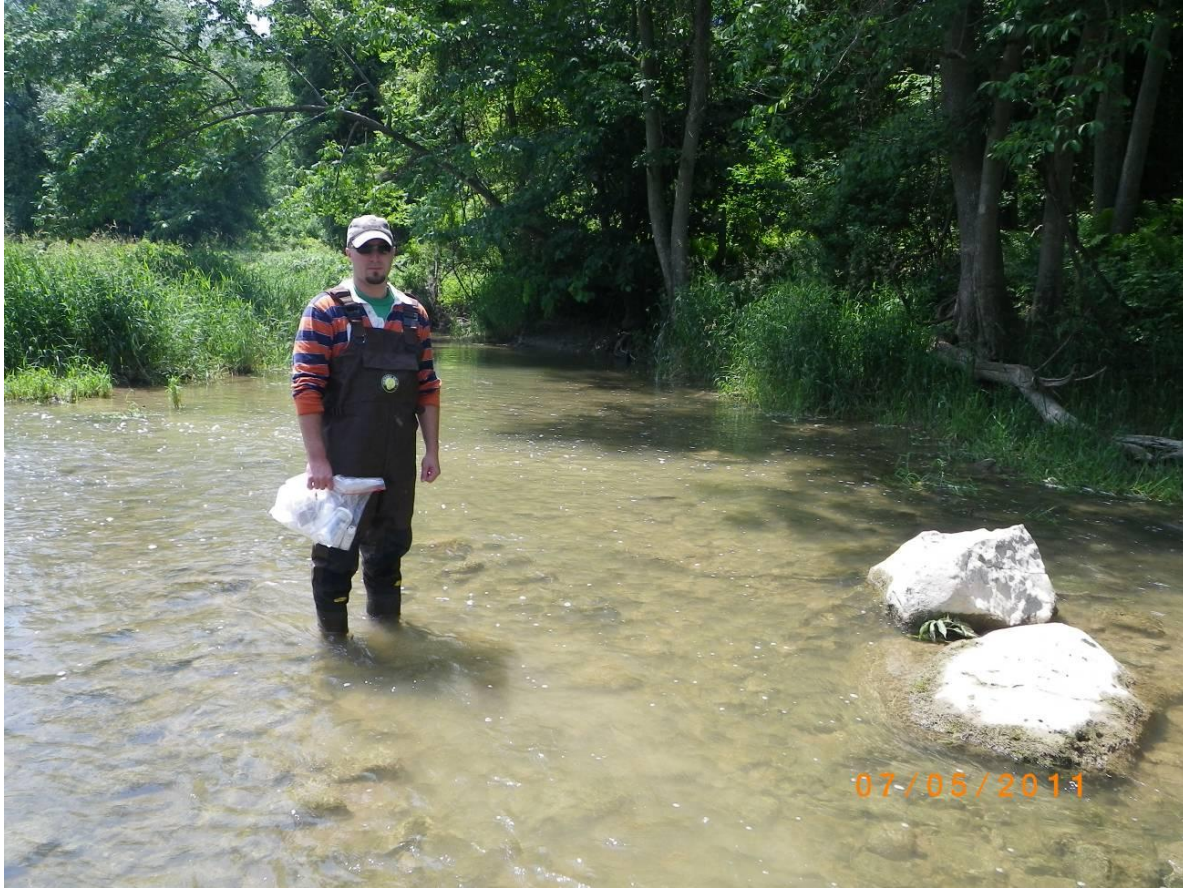
The side channel receiving the treated waste water discharge enters the Bayfield River from the south in a ponded embayment type of area. This is shown in one of the following attached pictures. During the first survey, the flow from the side channel basically remained

Picture showing confluence of the side channel that receives the treated waste water discharge and the Bayfield River on July 5, 2011.

along the south bank through the different riffle areas until a kink in the river approximately 250 meters below the confluence. At this small bend in the river to the south, the side channel flow traversed across the complete riffle mixing rapidly under the streamflow conditions present during our sampling on June 14, 2011. During our July 5, 2011 sampling when the streamflow in the Bayfield River dropped to nearly half of what it was on the previous sampling, the side channel flow mixed much faster and was completely mixed within the first 100 meters downstream.

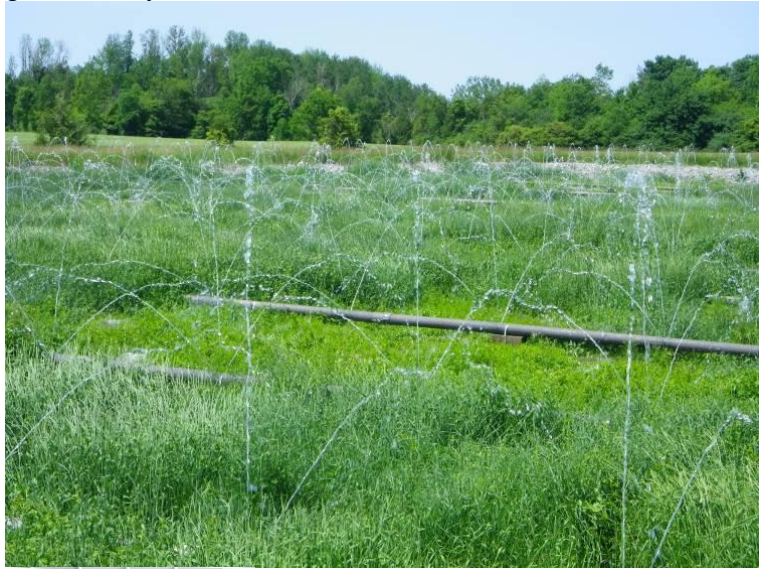
Treated waste water being applied to the intermittent sand filters.

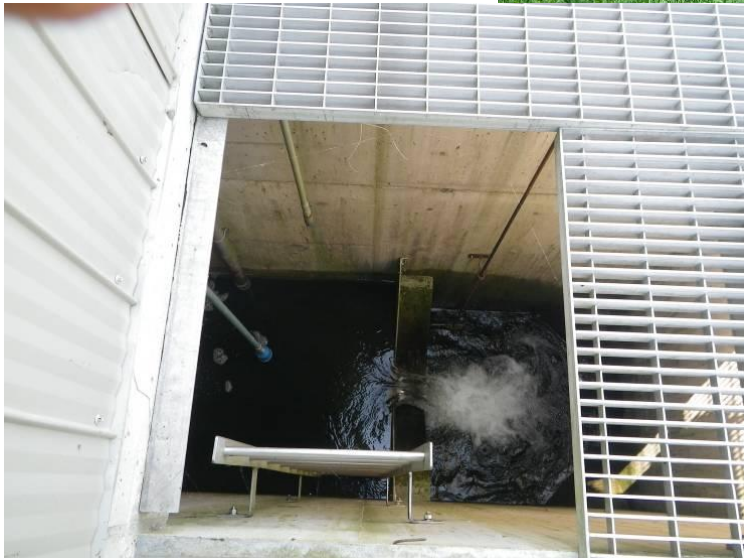
Under drainage from sand filters passing through V-notch weir.

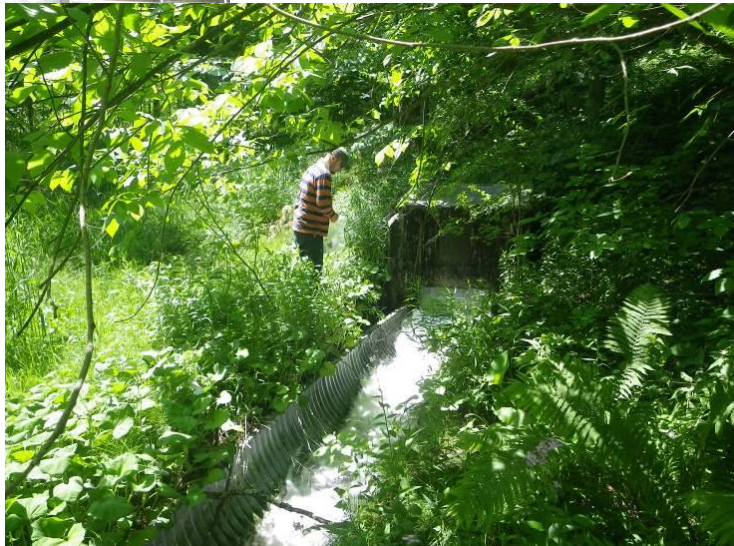
Discharge structure at bottom of the river valley.

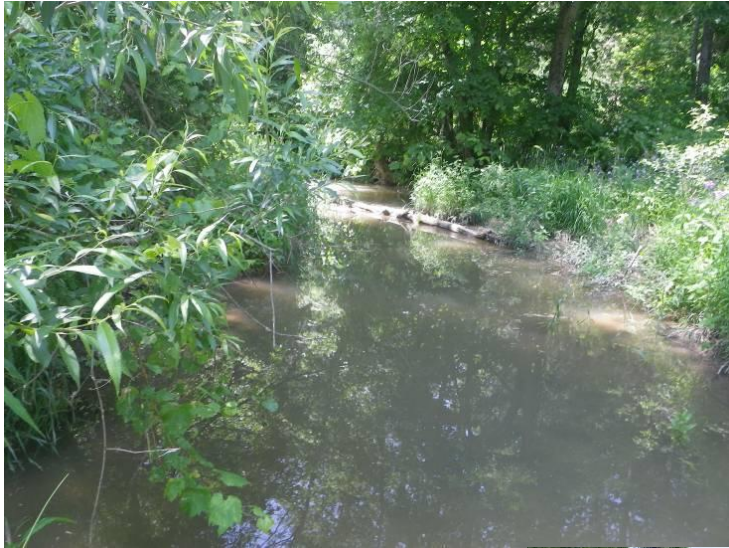
Size of side channel that receives treated effluent prior to mixing with the Bayfield River.

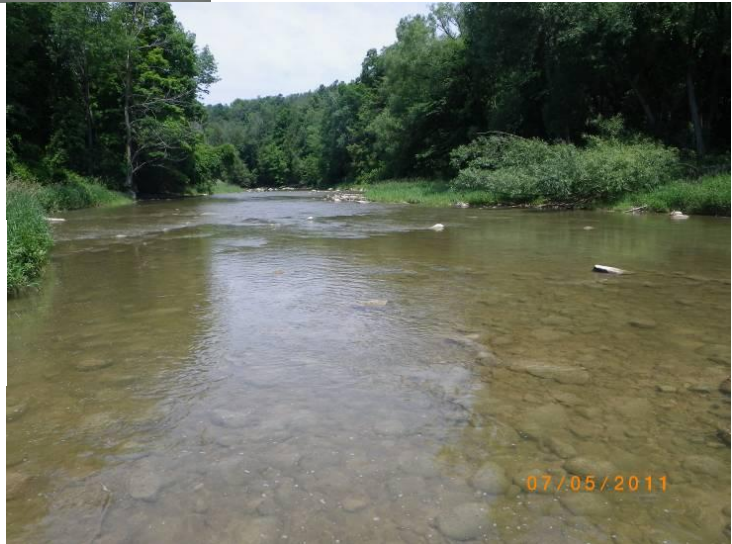
Bayfield River looking downstream from the confluence with the side channel.

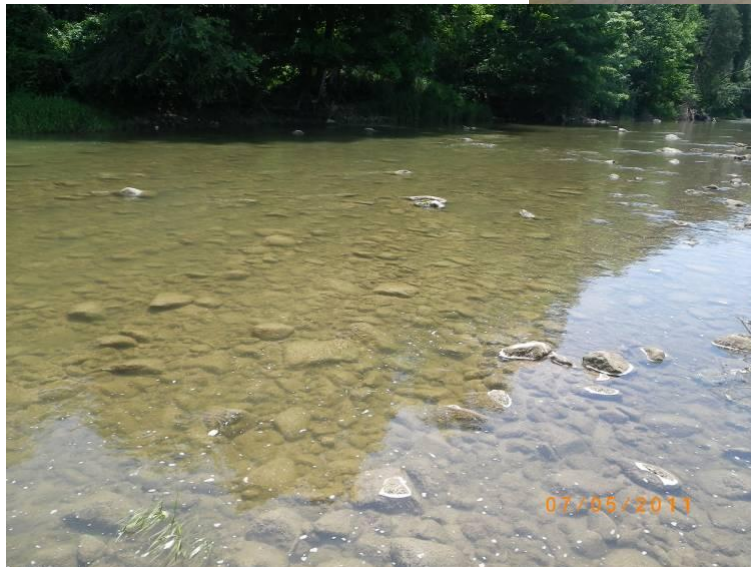
Bayfield River looking upstream and across the river from the upstream sampling location.

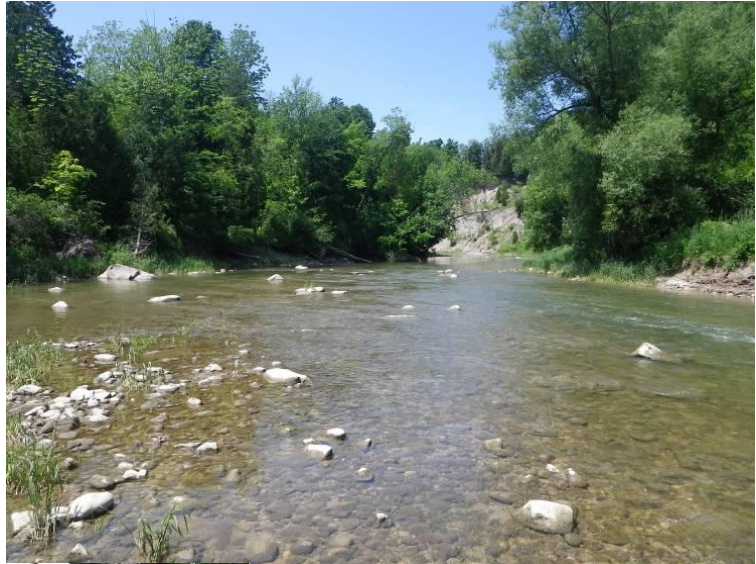
Bayfield River downstream in the area of complete mixing during the first sampling run.

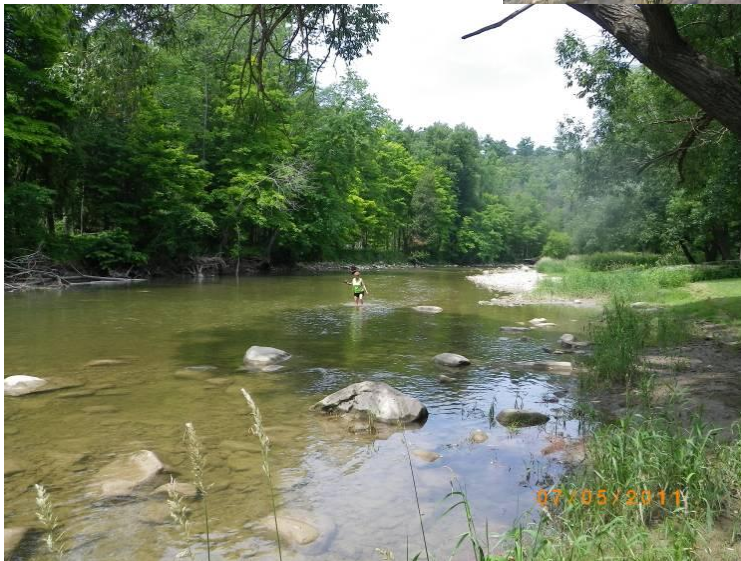
Bayfield River at end of road in Wildwood Trailer Park.

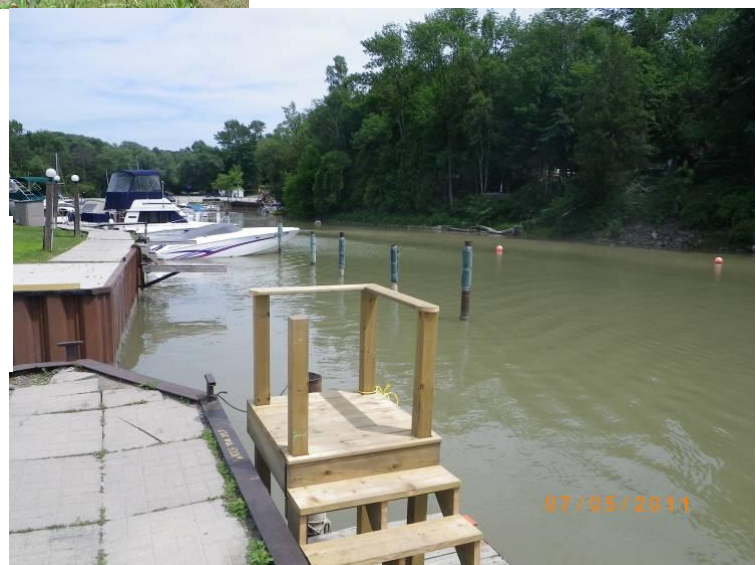
Bayfield River at Harbour Lights Marina near the gas pumps.

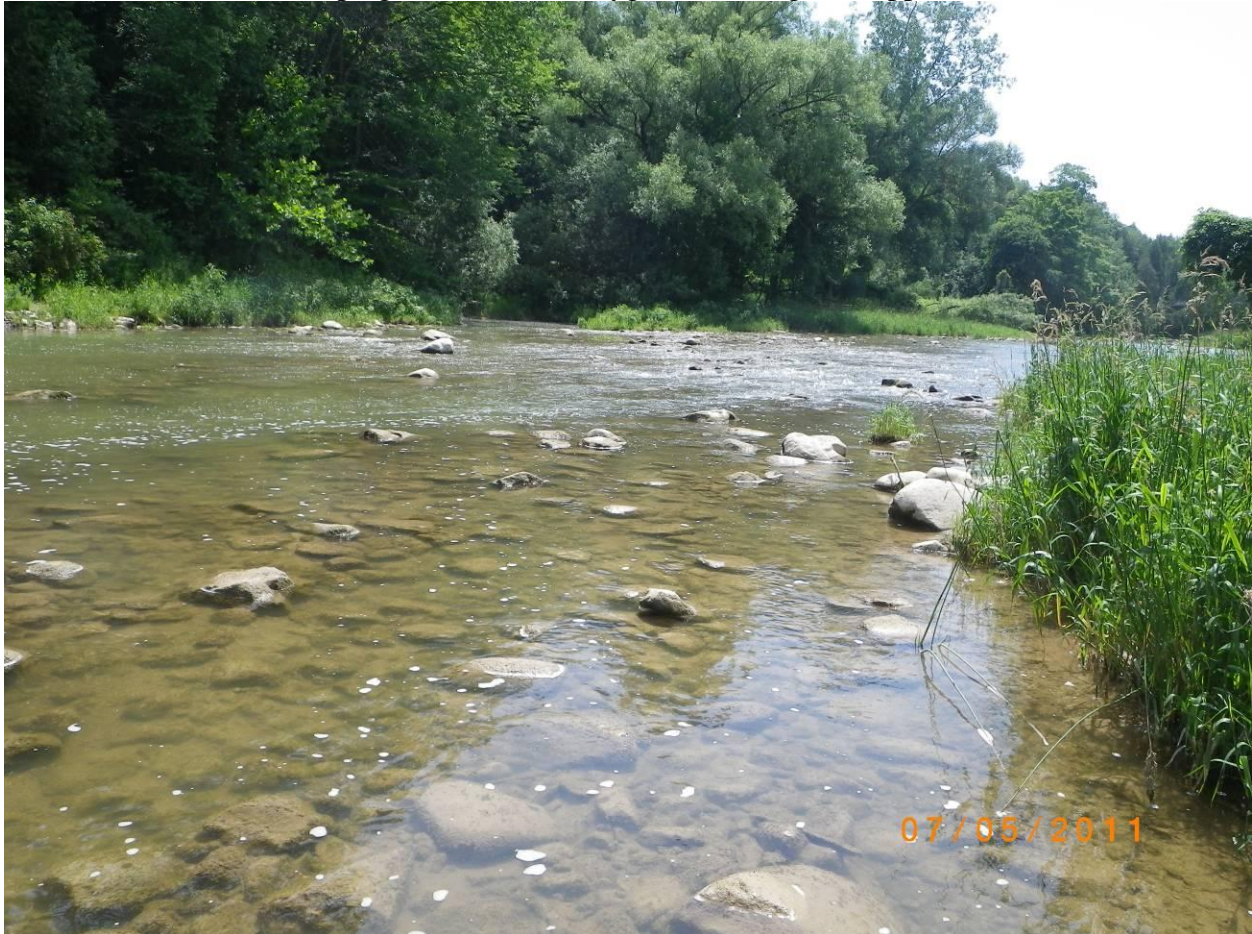
The shallow rocky nature of the Bayfield River as shown in the following picture is ideal for natural re-aeration keeping the dissolved oxygen levels high to support the various forms of

aquatic life present. One of the few species of aquatic life that would not find this type of habitat ideal is mussels. Most species of native mussels require softer and finer sediment so they can burrow into the sediment and filter out the phytoplankton drifting by.
