**CULTURAL HERITAGE EVALUATION REPORT/  
HERITAGE IMPACT ASSESSMENT**

**Cultural Heritage Evaluation Report/  
Heritage Impact Assessment,  
Bear Creek Bridge  
County Road 22/Egremont Road.  
Lambton County, Ontario**

**Proposed Bridge at Warwick  
Village, The King's Highway No.  
7, 1931**

Lambton County Site No: 22-3-334  
October 2016

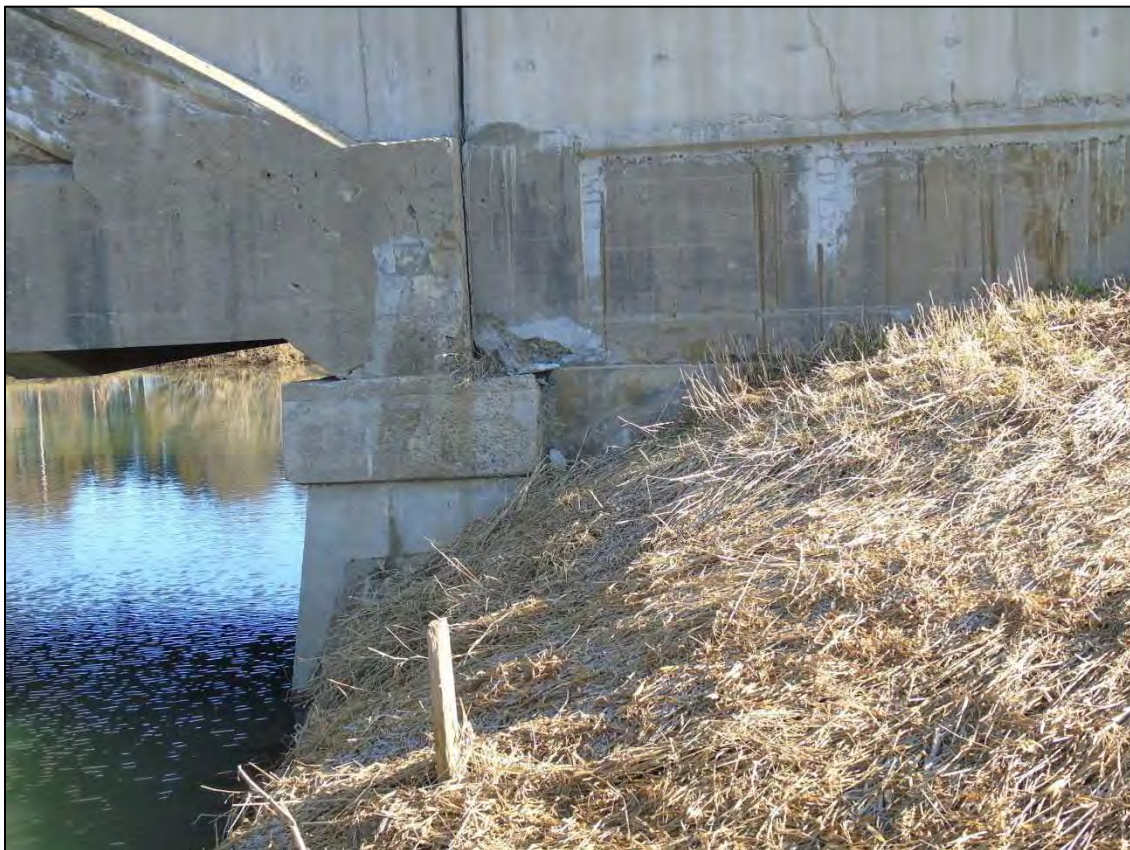
**Image 15: Detail showing concrete west abutment of Bear Creek Bridge**

vertical posts are located under the arch, connecting the arch to the deck. The faces of the arches are adorned with concrete panels that are sunken into the concrete to create a panelling effect for aesthetics (Images 15 – 19).

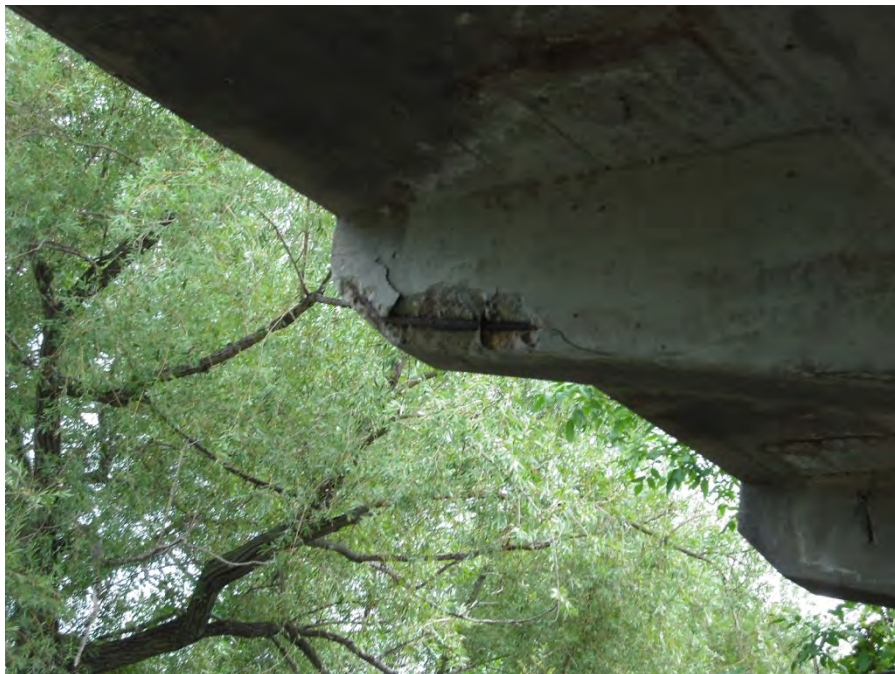
Spall with exposed rebar

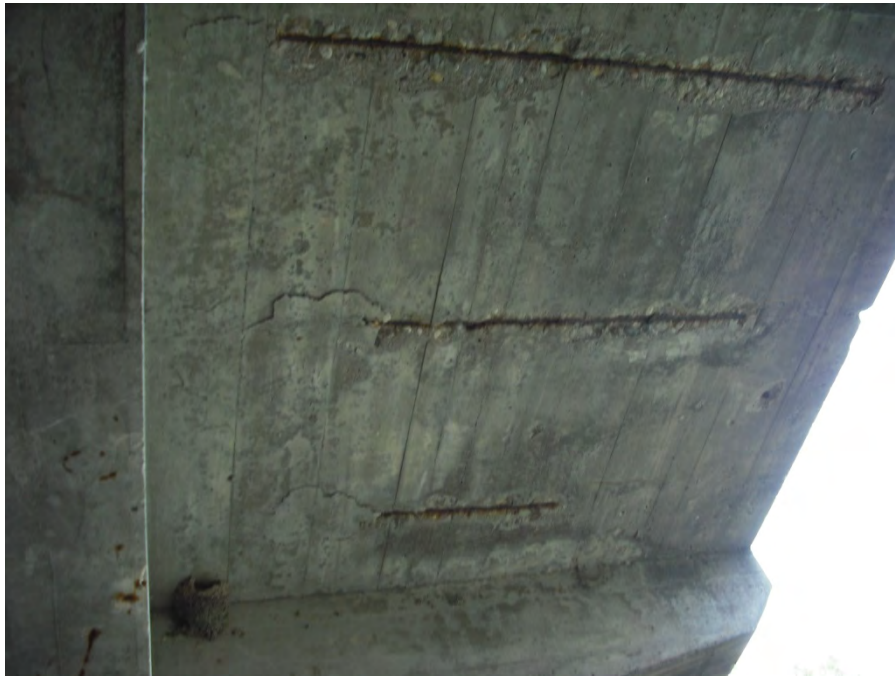
Spall with exposed rebar

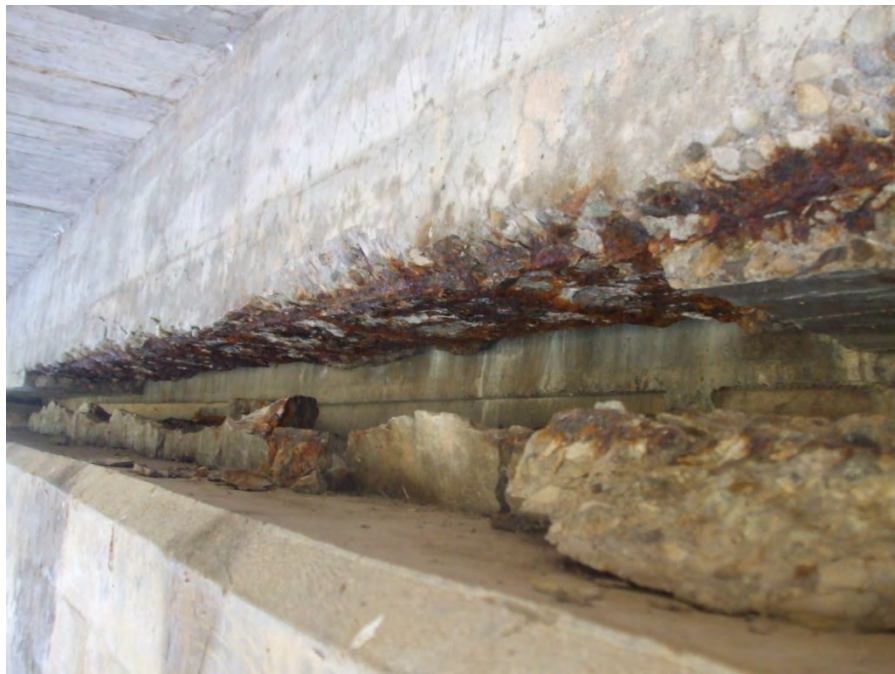
Severe spall with exposed rebar - east floor beam

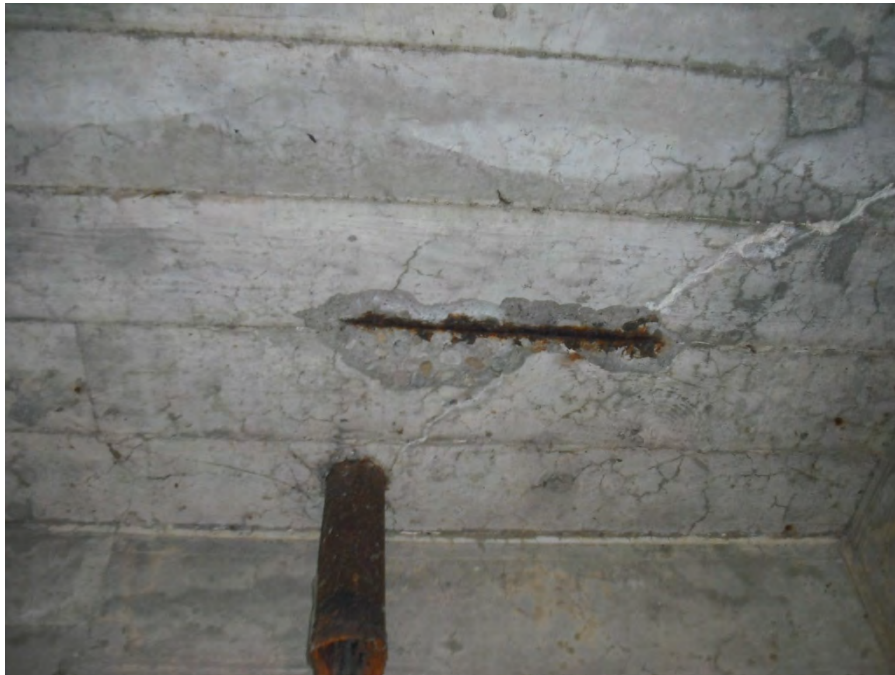
Spall with exposed rebar

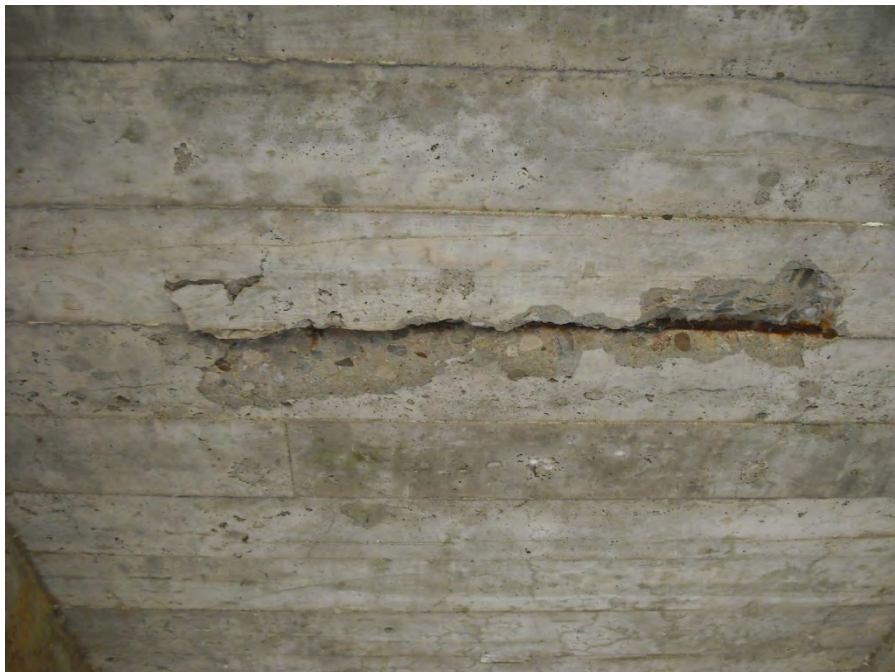
Spall with exposed rebar

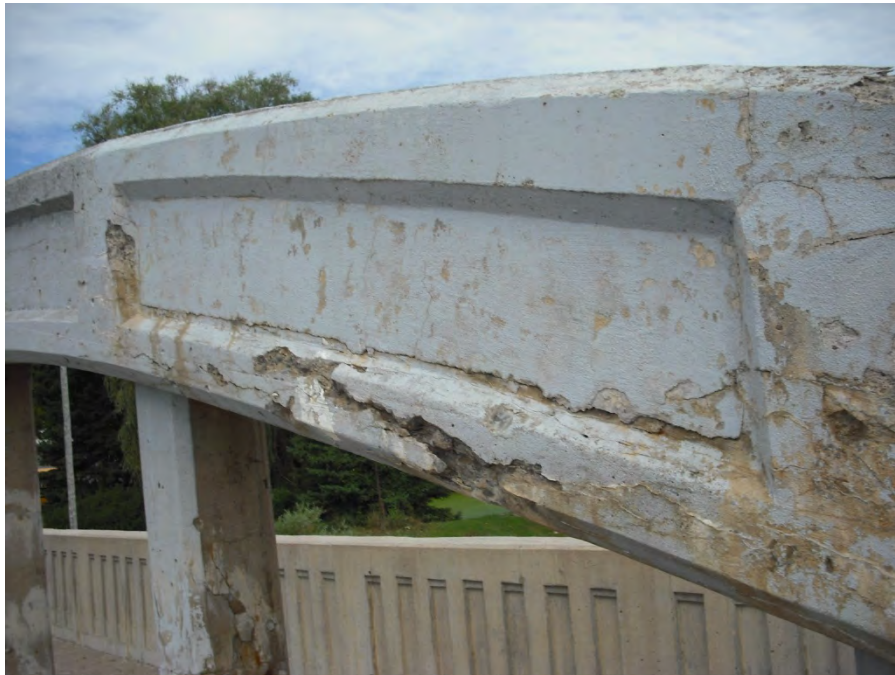
Spall on north arch

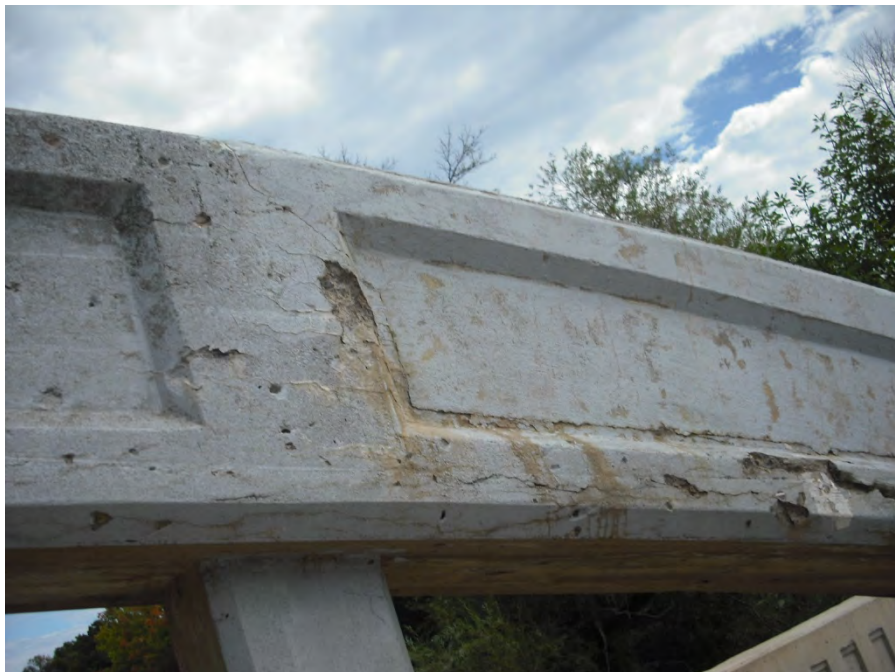
Spall on north arch

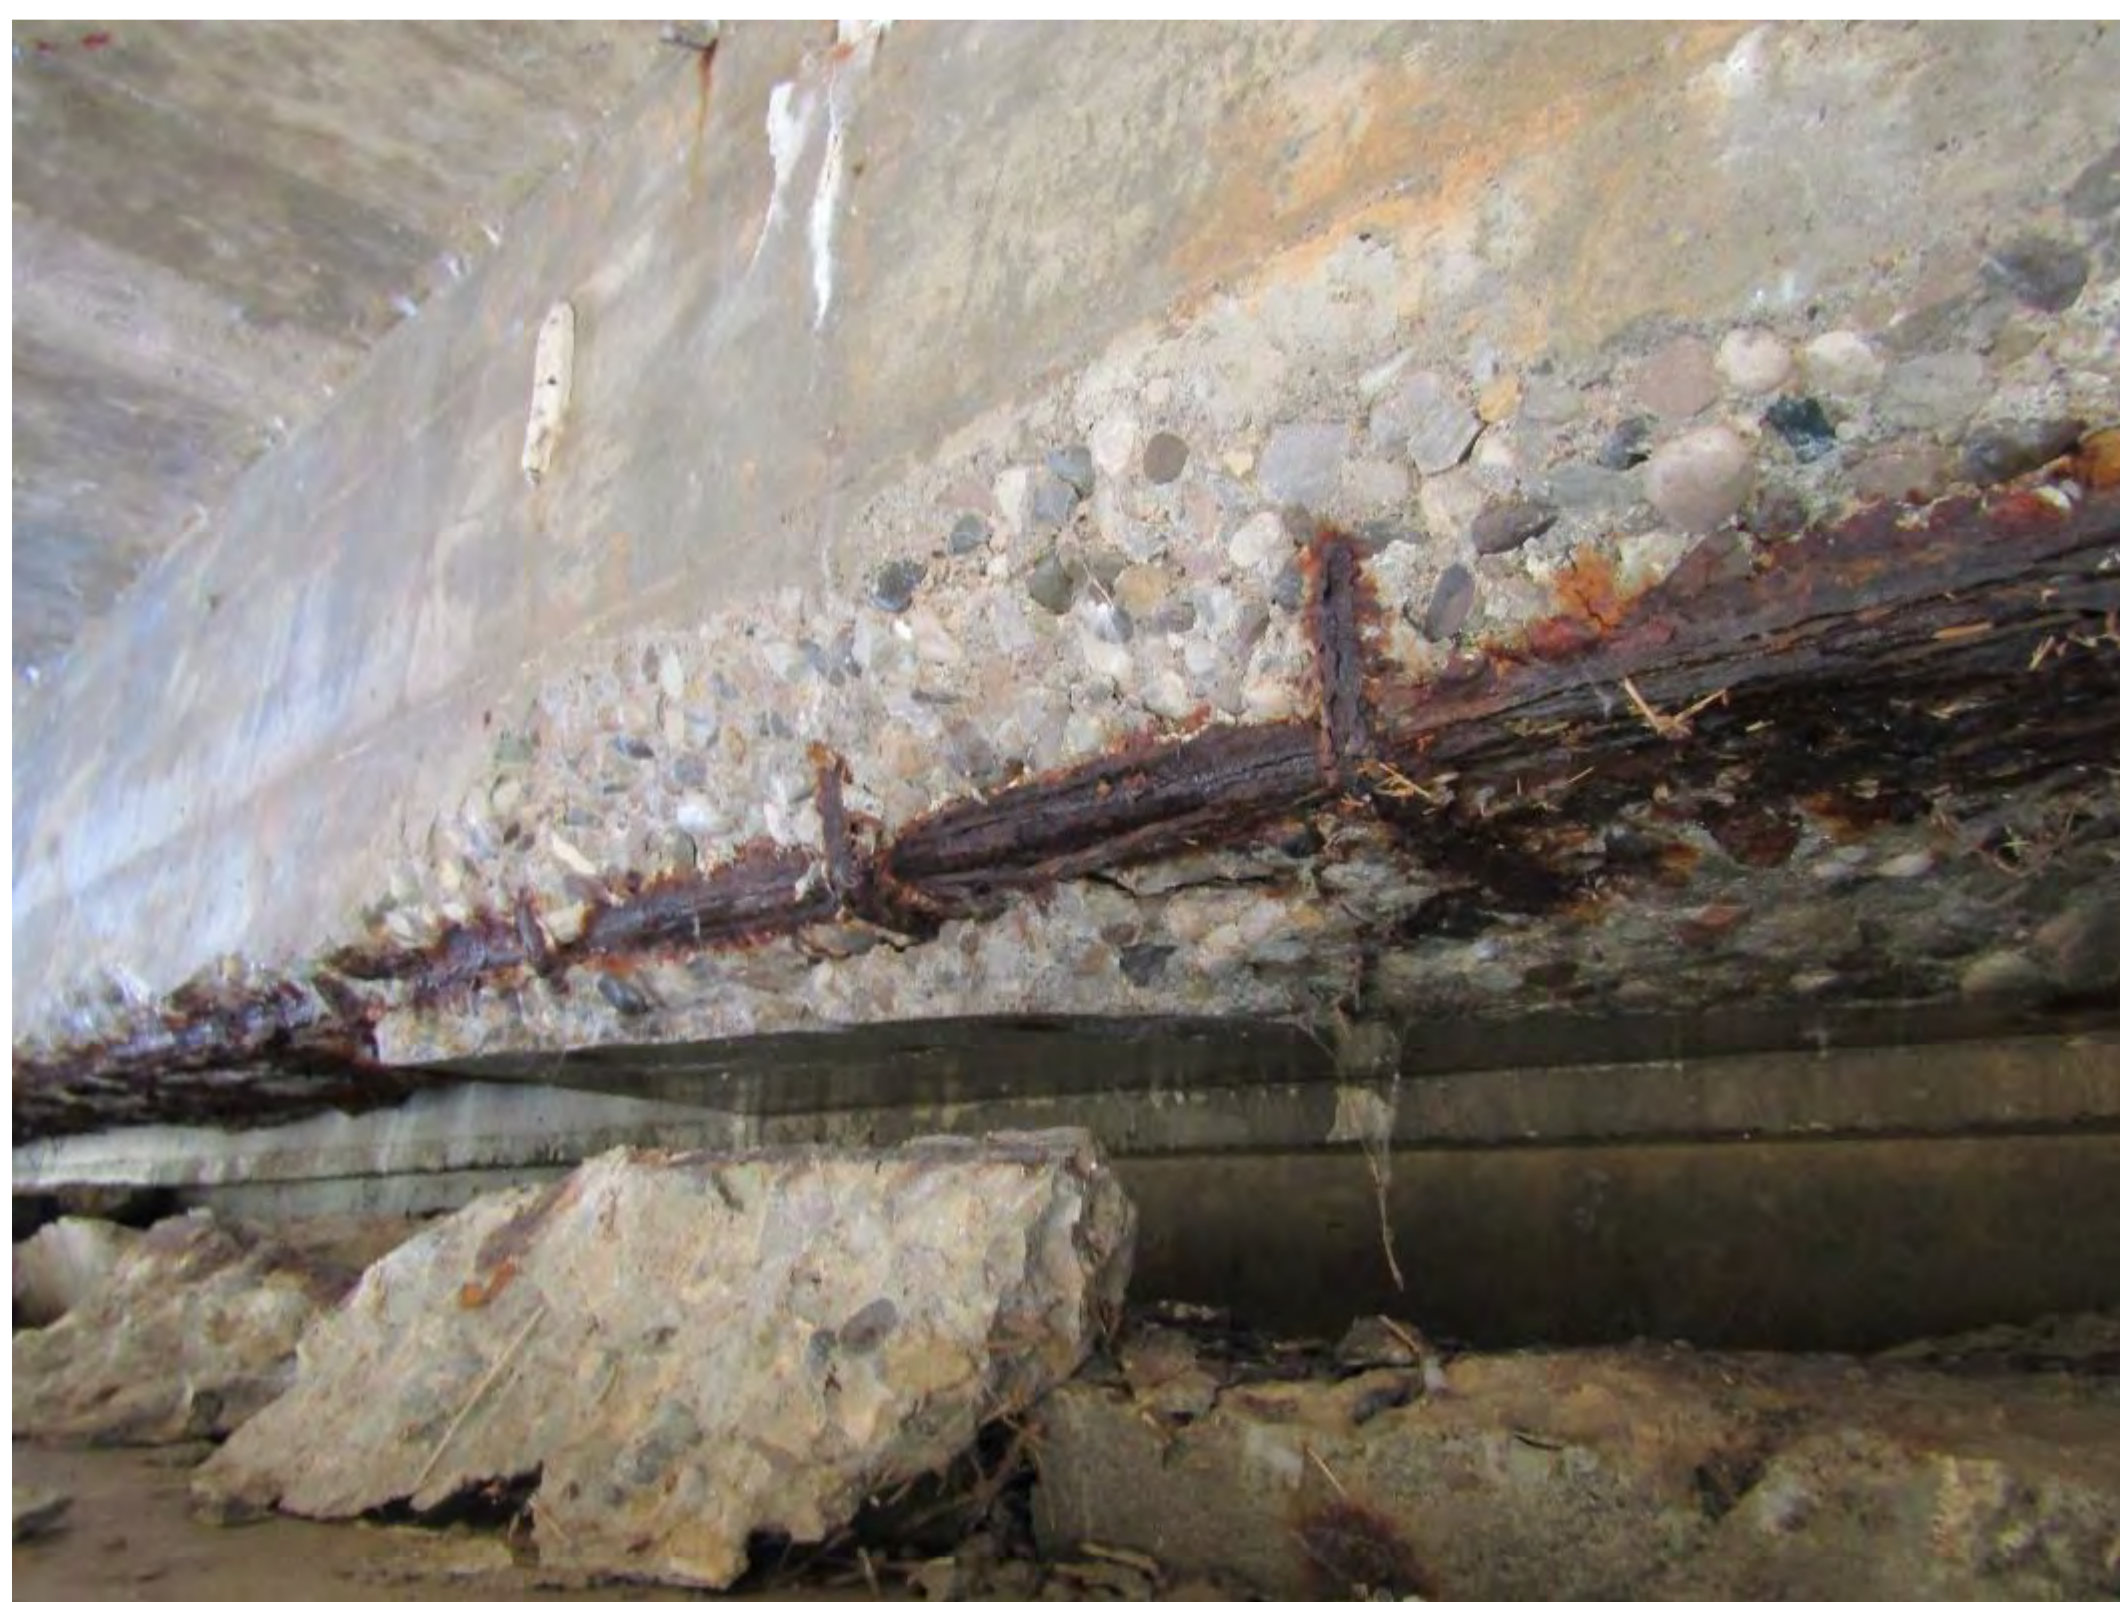
- CRACKING ON UNDERSIDE OF SOUTH ARCH NEAR MID-SPAN
- MULTIPLE CRACKS AND SPALLING ON NORTH ARCH
- SPALLING WITH EXPOSED REBAR ON UNDERSIDE OF DECK
- CRACKING AND SPALLING AT BASE OF COLUMNS THROUGHOUT
- SEVERE SPALLING ON FLOOR BEAMS AT EAST ABUTMENT
- MEDIUM TO WIDE CRACKING ON UNDERSIDE OF FLOOR BEAM AT WEST ABUTMENT

EXPOSED REBAR

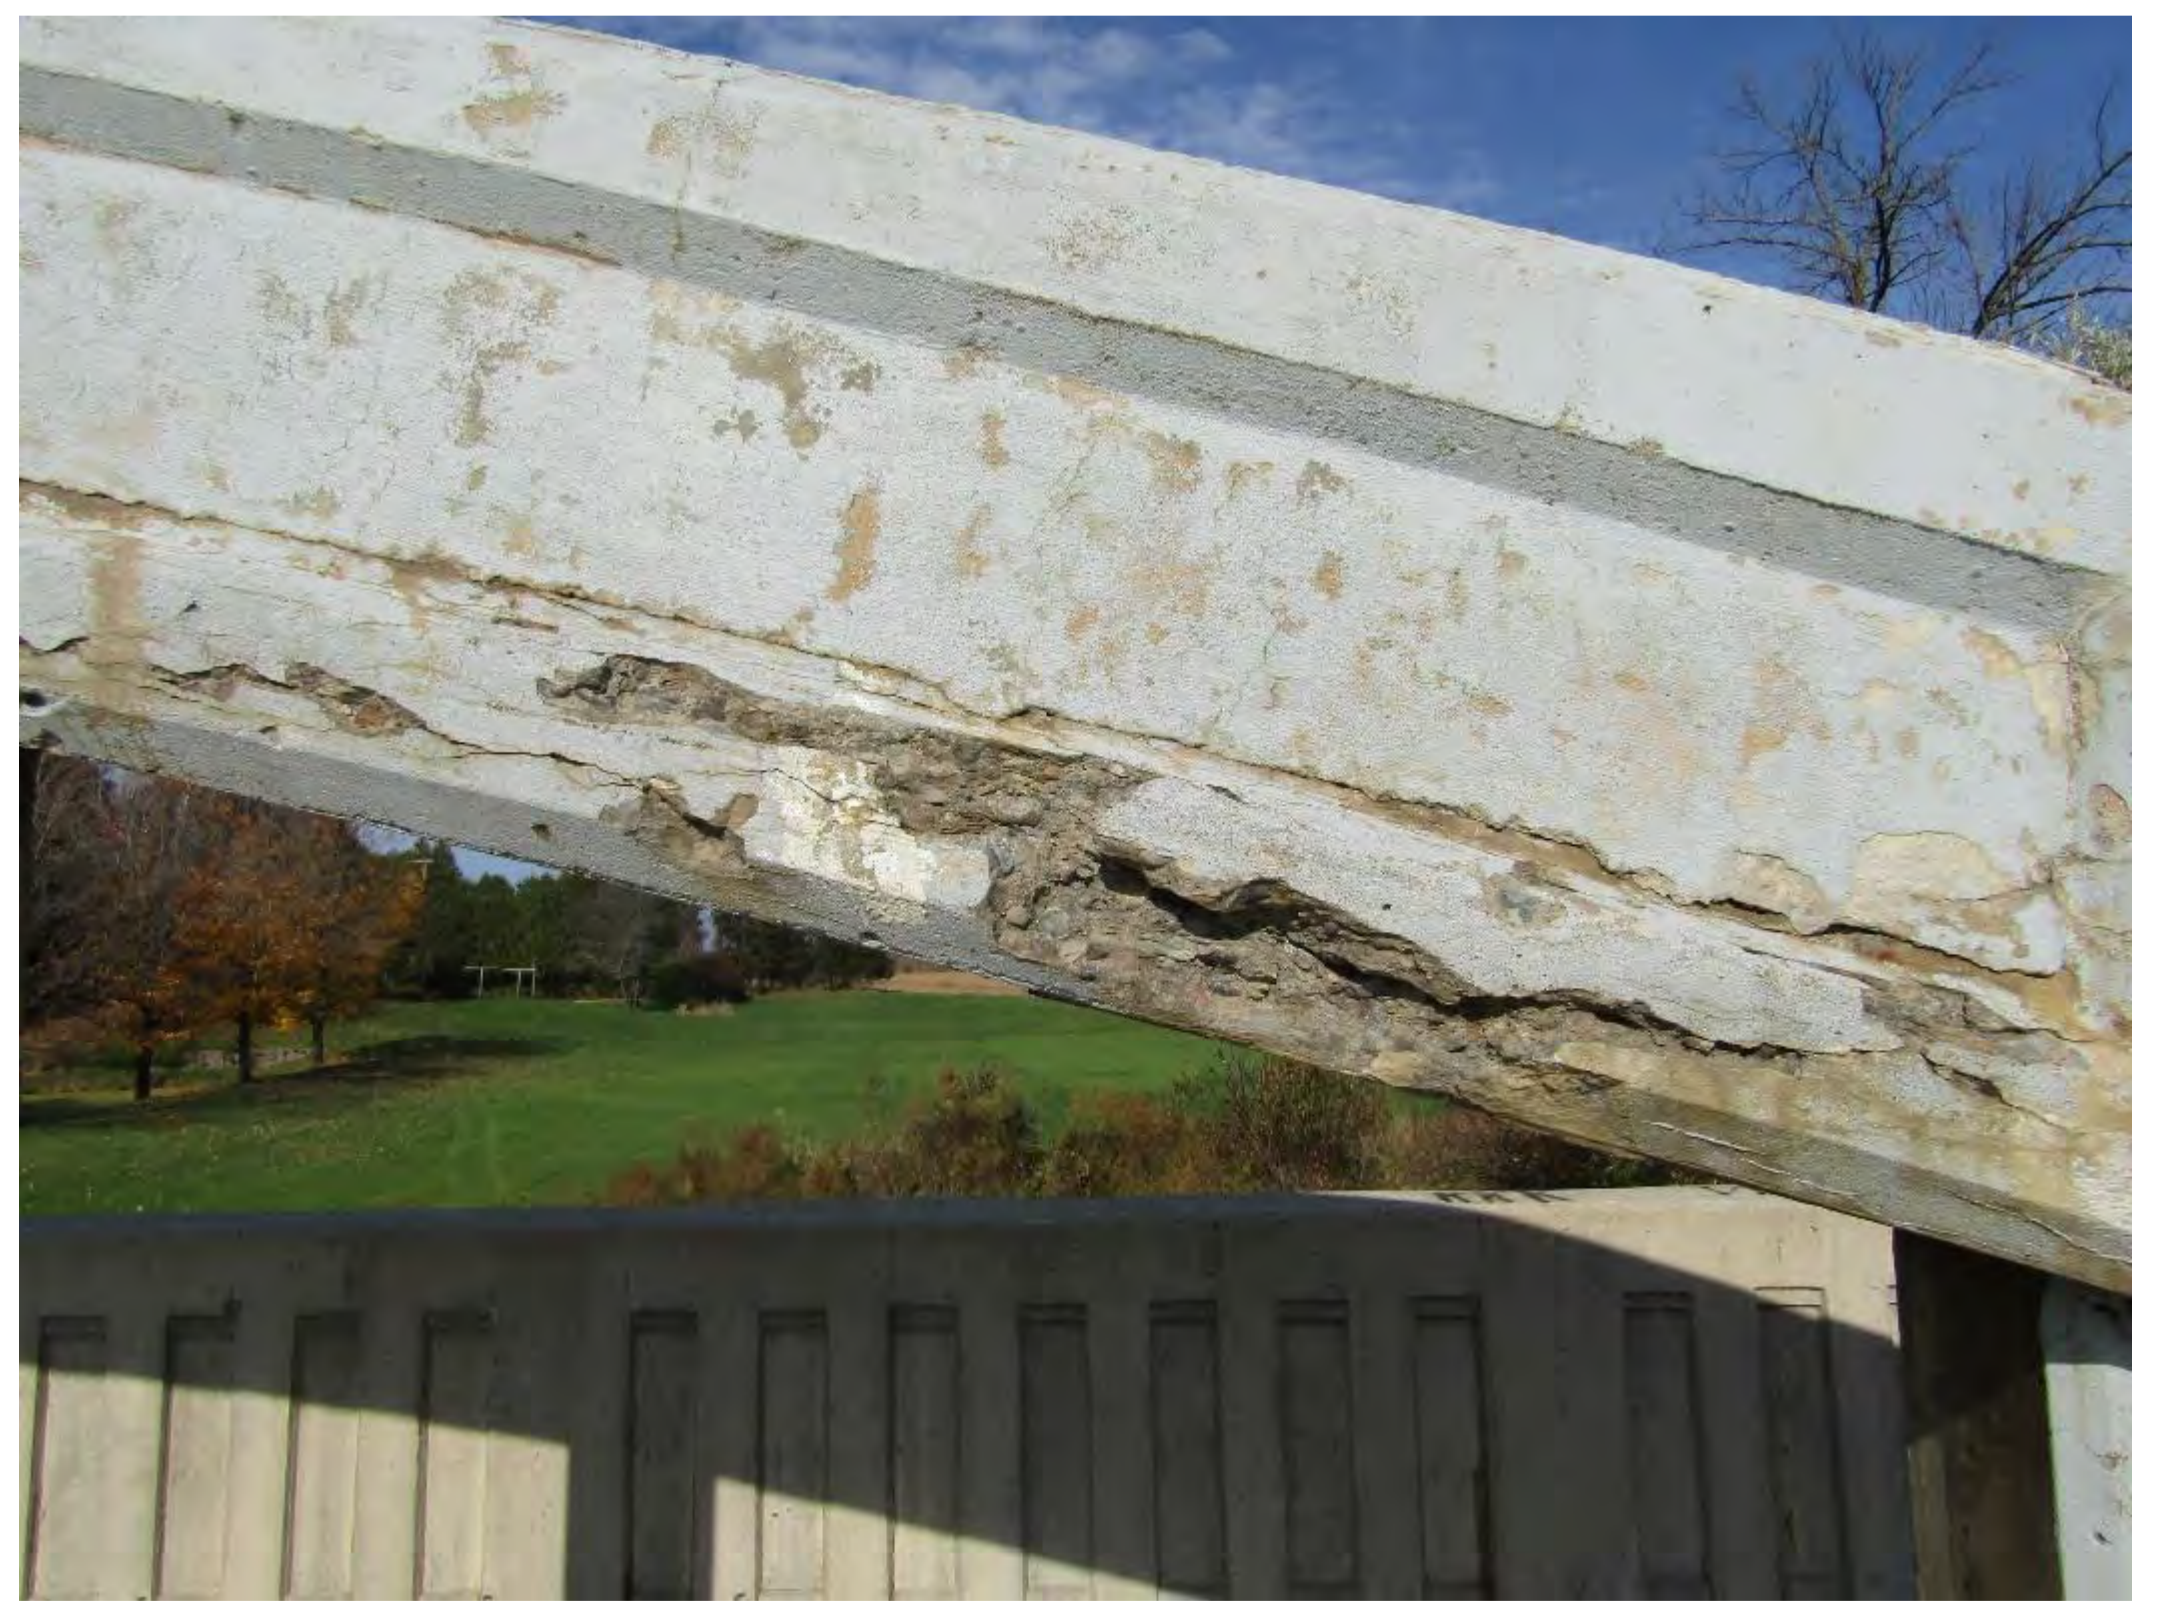
SPALLING ON NORTH ARCH

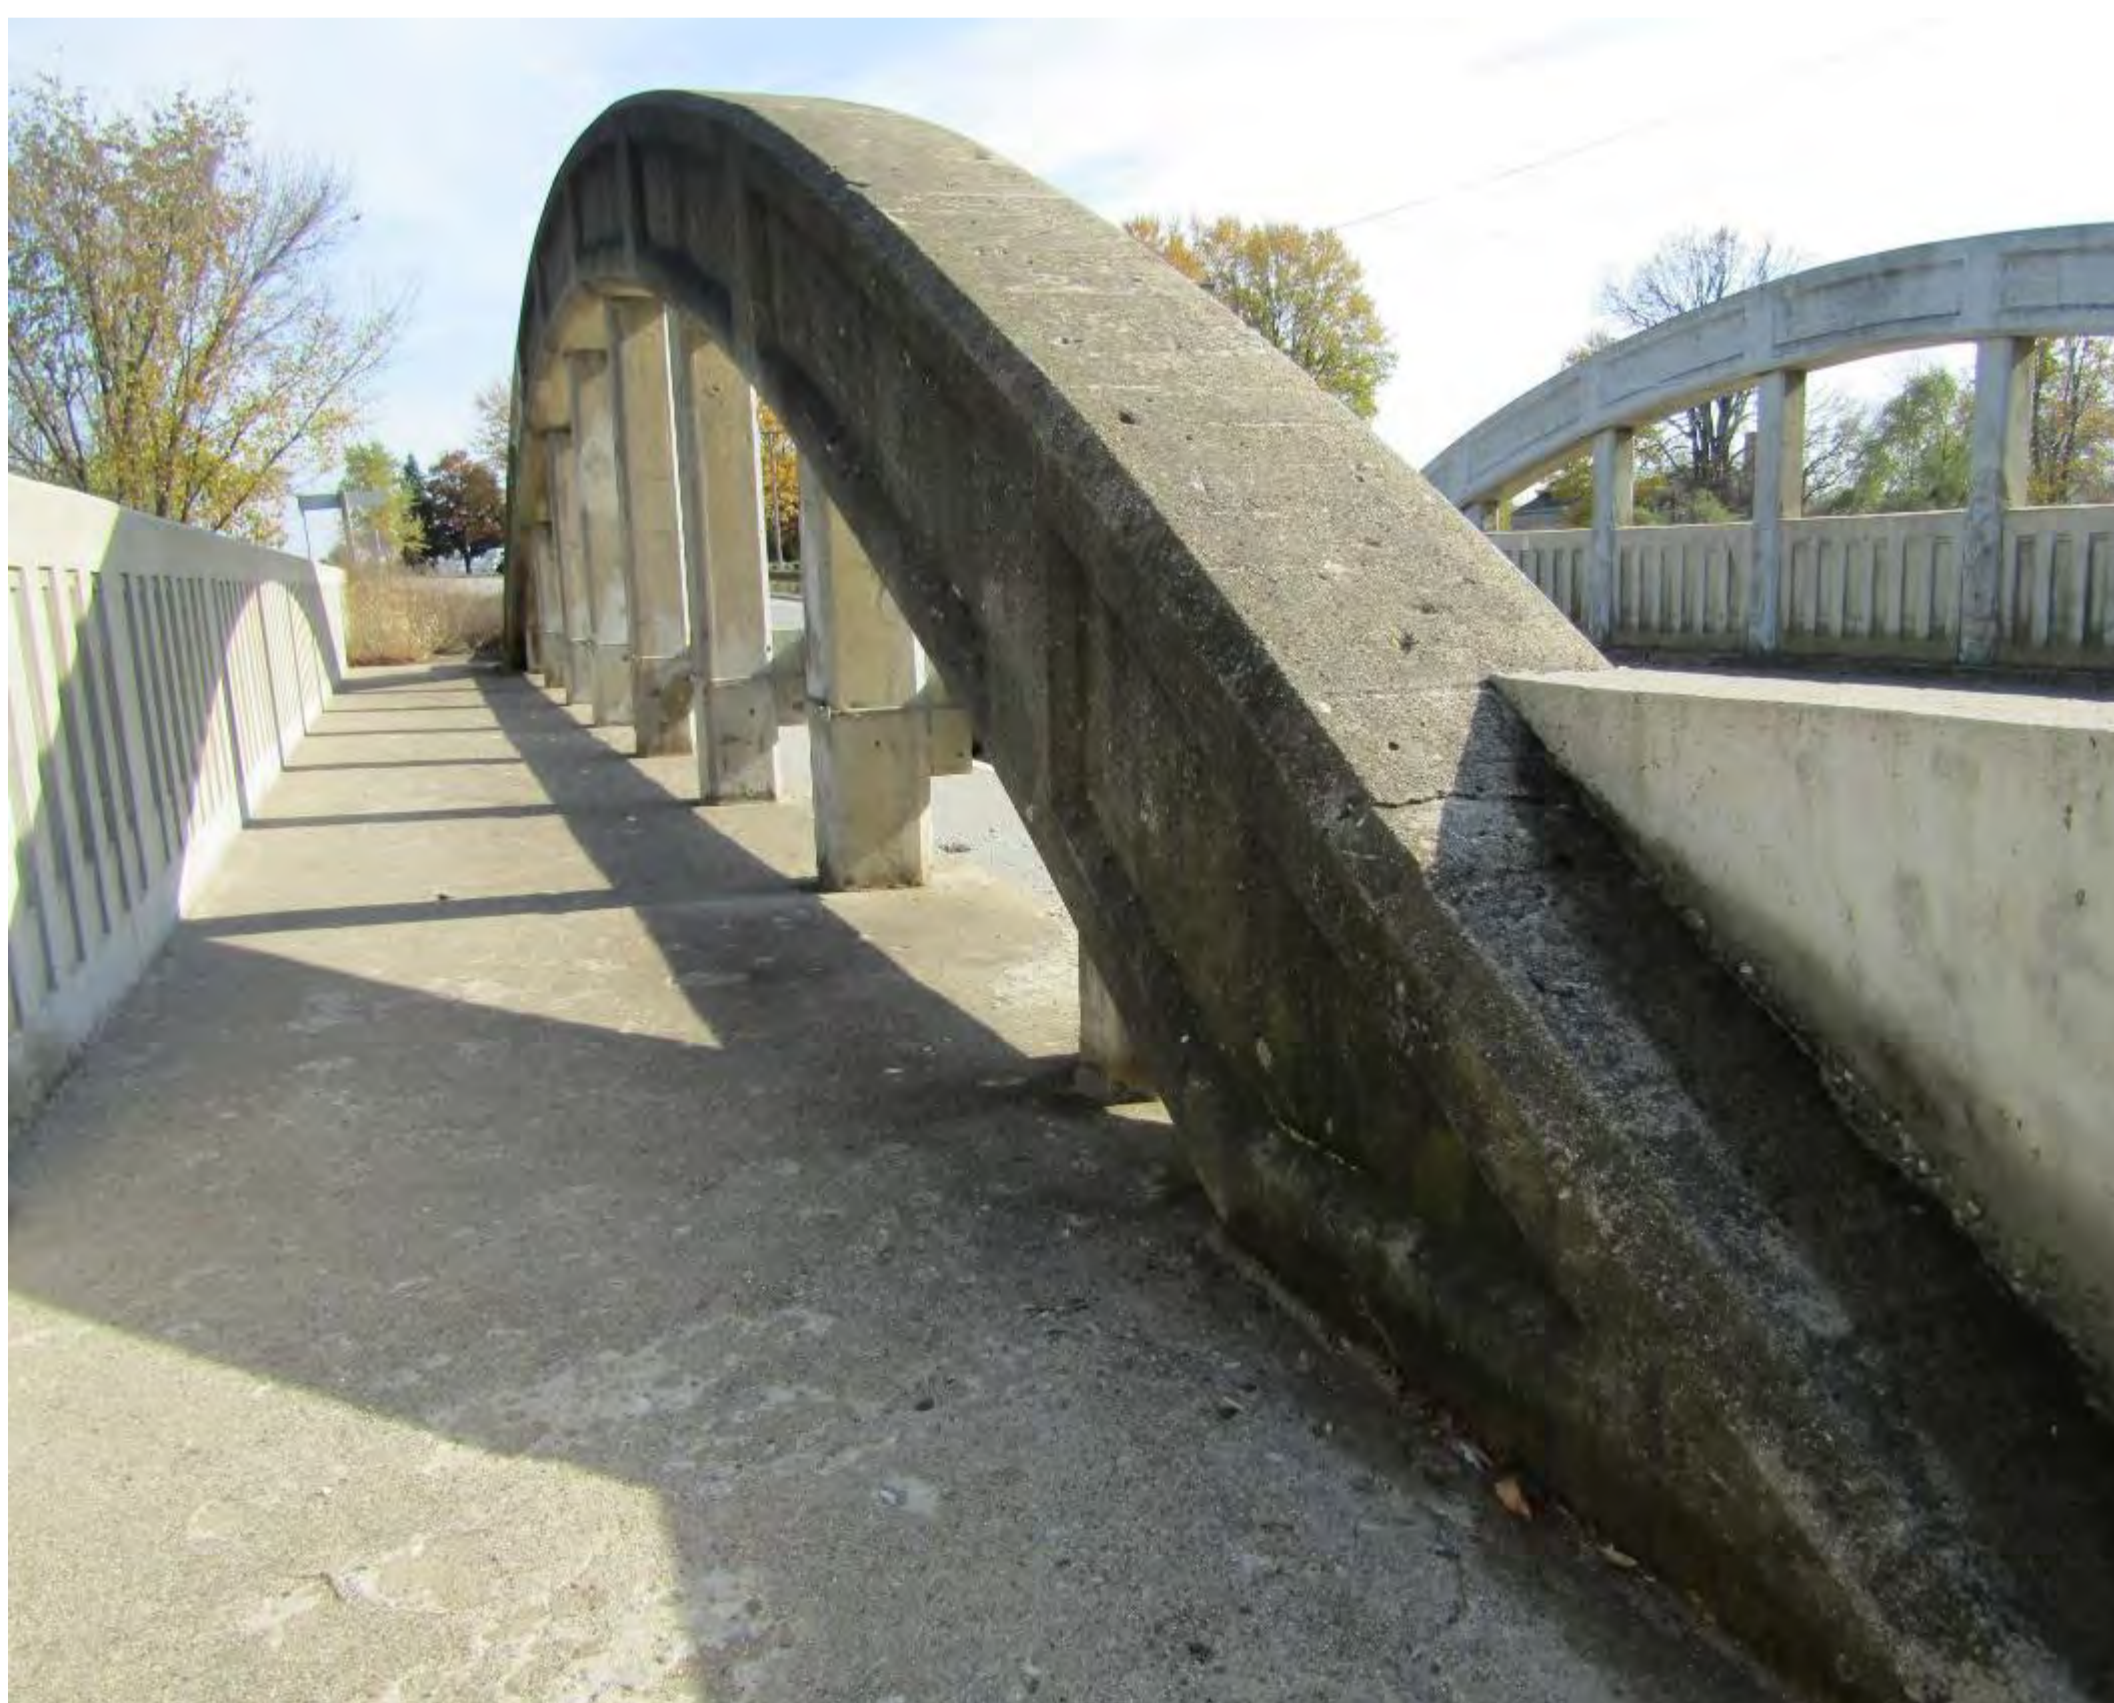
VIEW SHOWING SYMMETRICAL ARCHES AND CONCRETE SIDEWALK

- CONCRETE BOWSTRING ARCH DESIGN:
  - SYMMETRICAL ARCHES ON THE NORTH AND SOUTH SIDE
  - CONCRETE PANELLING SET INTO THE ARCHES
  - VERTICAL CONCRETE POSTS UNDER THE BOWSTRING ARCHES
  - CONCRETE GUARDRAILS WITH INSET CONCRETE PANELS (CIRCA 2004)
  - CANTILEVERED CONCRETE SIDEWALK

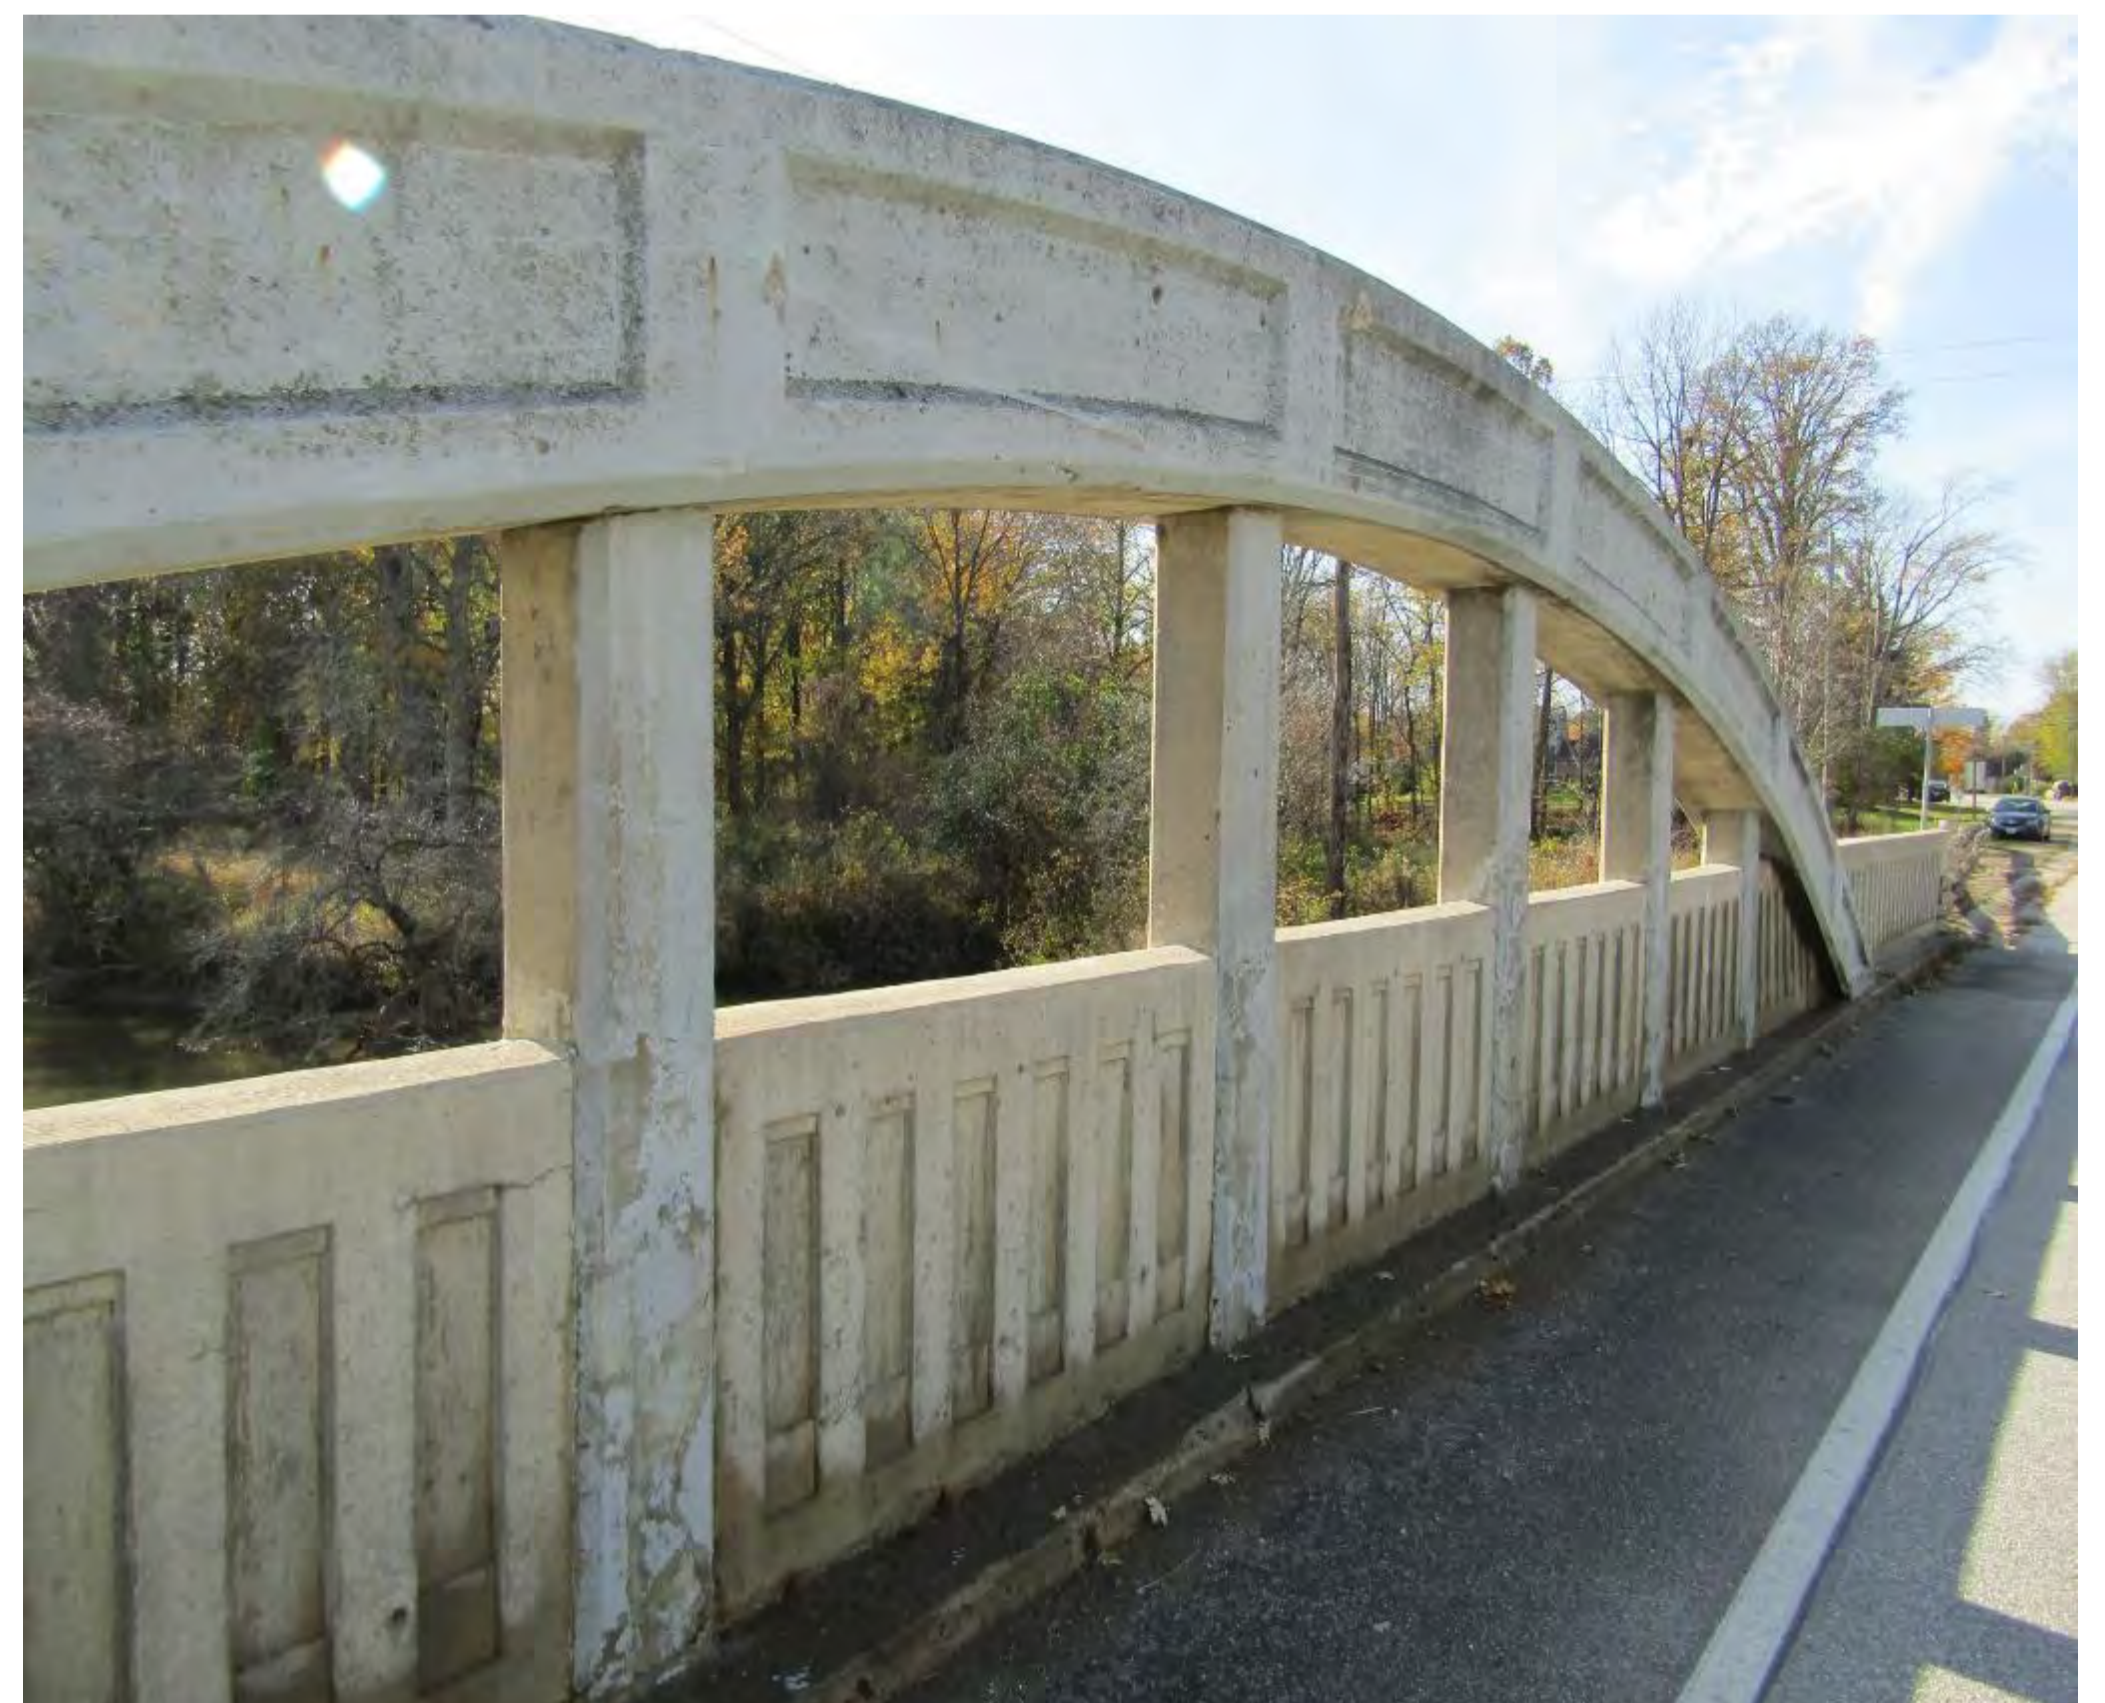
VIEW SHOWING CONCRETE PANELING SET INTO ARCHES

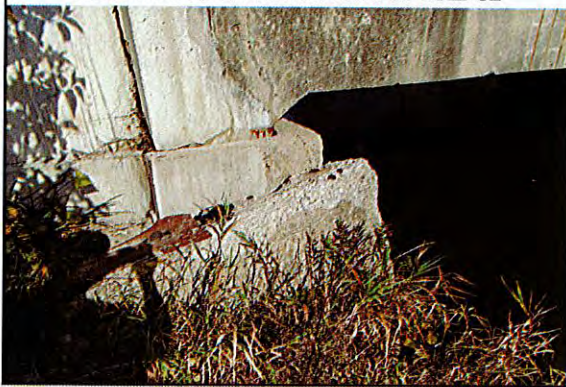
SPALL WITH EXPOSED REBAR  
CLIFF SWALLOW NESTS
