HURON-KINLOSS COMMUNITY SEPTIC INSPECTION PROGRAM

Report on the first round of inspections for the Huron-Kinloss Community Septic Inspection program

CYCLE 1 REPORT

B. M. ROSS AND ASSOCIATES LIMITED

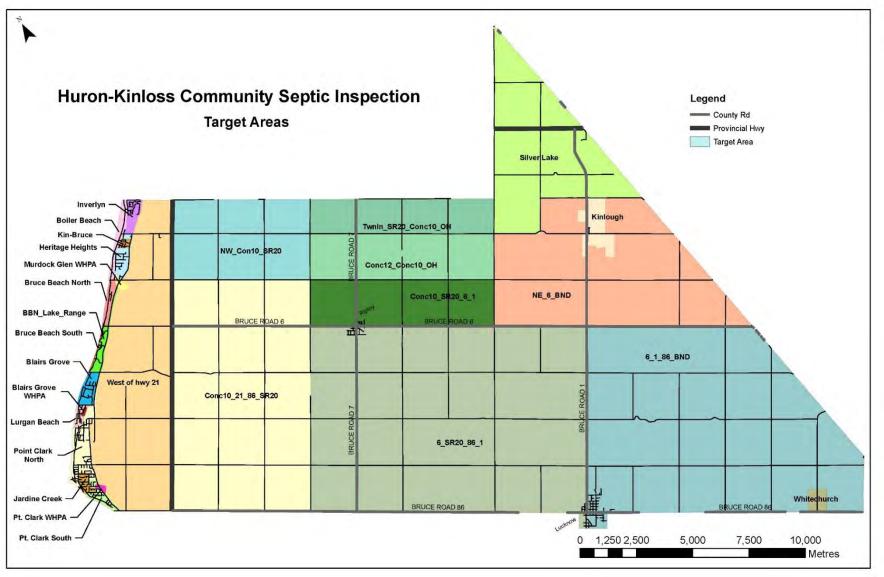
Figure 2.1 Target Area

For the purposes of the program, the Township was divided into target areas. These areas, as shown in Figure 2.1, were identified based on a number of characteristics, including the number of properties requiring inspections, general location (e.g. lakeshore or rural), areas identified in the 1997 study, and the presence of distinct communities (e.g. Kinlough and Whitechurch). Certain target areas were prioritized earlier in the program than others based on the suspected ages of systems, local soil conditions, usage (seasonal vs permanent), and location.

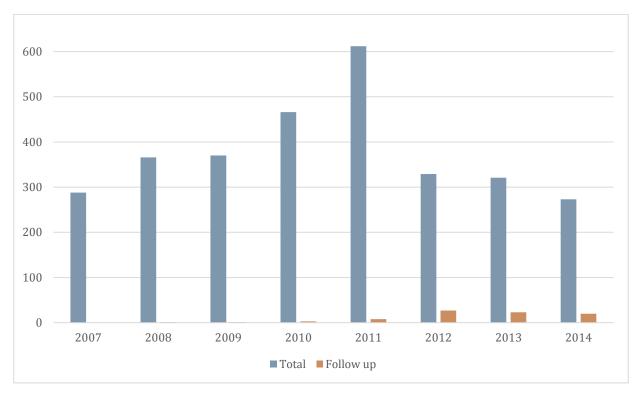
Figure 3.1 Inspections completed as part of the HKCSI program, per year, 2007-2014

In the first year of the program, which served as a pilot for marketing strategies to promote the program, there were 288 inspections completed. In the subsequent years, the number of inspections per year rose to a high of 612 in 2011. The high number of inspections completed in 2011 is due in part to the high rate of participation in the Port Clark North target area in its first target year; significantly more residents booked an inspection in 2011, following initial notification in this target area than expected.

Given that the early adopters and early majority of the target population of the program had already participated by 2011, it was expected that the number of inspections would decline in the following years. Significantly more effort was required to encourage property owners to participate between 2012 and 2014. In the last year of the cycle, the property owners who had not participated were mailed final notice letters stating the consequences of not completing and inspection (see Section 1.1). Property owners also received phone calls and doorknocking visits by the inspector to encourage participation in the program. The result of these extensive efforts was 273 inspections in the final year, leaving 54 uninspected properties, including 3 refusals.

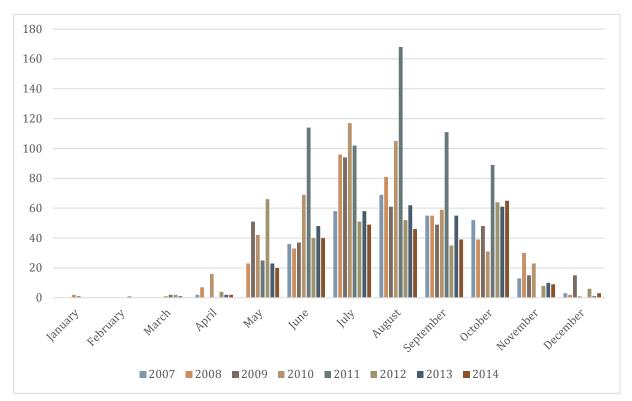
Figure 3.2 Inspections completed per month, 2007-2014

Inspections were generally carried out between May and October; however, in certain years, weather conditions permitted inspections in April, November and December as well. In 2009, as a result of the mild conditions, 15 inspections were completed in December. July and August tended to be the busiest month for inspections, averaging approximately 80 inspections per month over the 8-year cycle. This trend is especially pronounced in years where seasonal areas were targeted. Approximately 55 inspections per month were averaged in September and October across the first round of the program. In these months, inspections were typically done on farm properties or as a result of the installation of a new or replacement septic system.

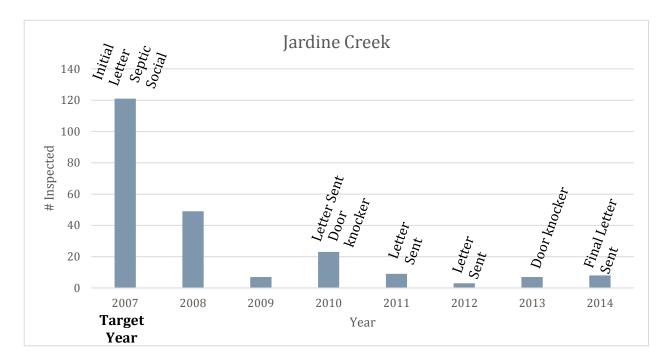
The number of inspections in the target area between 2007 and 2014 are shown in the figure below. Points and methods of contact are indicated on the figure. Following the initial letter for the target area, a septic social was held at the cottage of the local beach association president. The event was well attended. Approximately half (53%) of the properties requiring an inspection in the target area were inspected in the first year. A further 21% were inspected in the following year without any contact. A reminder letter and door knocking efforts in 2010 encouraged another 23 residents (10%) to participate. The remaining 12% required additional contact to participate.

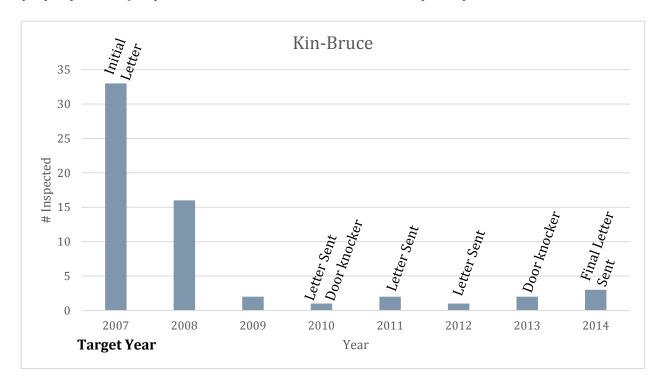
Program uptake, as shown by the number of inspections per year from 2007 to 2014 is shown in the figure below. Similar to Jardine Creek, which was also one of the first target areas, there was a strong initial response to the program in Kin-Bruce. Over half of property owners with septic systems had an inspection completed after receiving an initial letter. In the following year, another 26% of residents participated without further prompting. The remaining 20% of residents (11 property owners) required additional contact and reminders to participate.

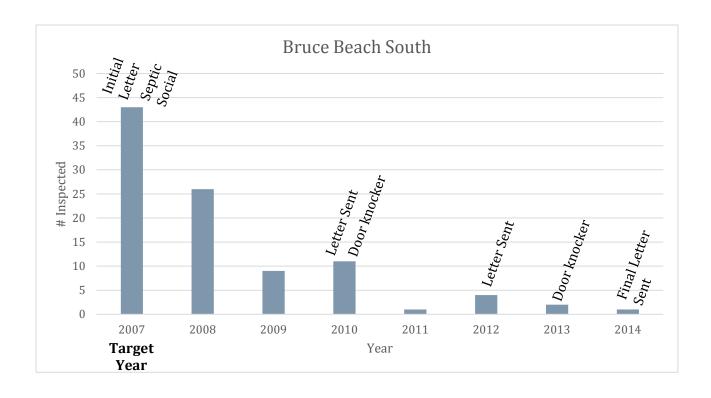
The proportion of property owners in Bruce Beach South who had an inspection completed following the initial contact letter, was less than what was observed in the other areas targeted in 2007. A septic social was also held at a property within the target area. However, less than half of property owners contacted (approximately 44%) booked an inspection in 2007. In the following year, another 36% of property owners participated without any additional contact. Property owners who had to participate in 2010 were sent another letter reminding them of the program, in addition to doorknocker efforts. The result of these efforts was another 11% of property owners participating. The remaining 8 property owners required additional contact up until 2014 to participate.

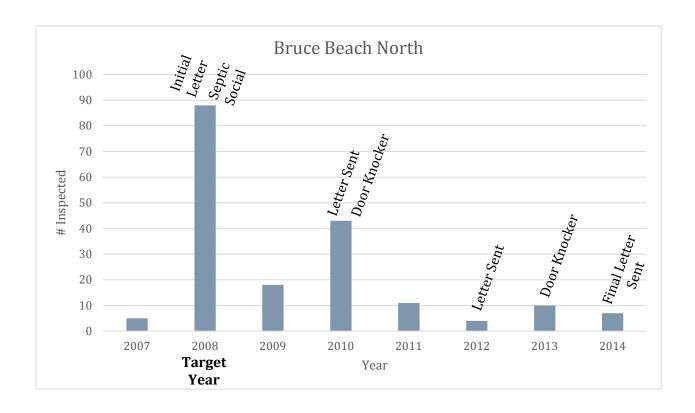
An initial letter informing property owners of the program was sent in 2008, however there were 5 residents who participated prior to receiving the letter. Following the initial letter, an additional 88 property owners had inspections completed, which captured just short of 50% of properties requiring inspections. In the following year, the number of inspections completed in the target area sharply declined. Another letter and doorknocking efforts in 2010 encouraged 43 additional property owners (22%) to participate. Significant efforts with additional letters, doorknocking and phone calls were required between 2011 and 2014 to encourage the remaining 32 property owners to have an inspection completed. Again, it is noted that there are 2 properties that have not yet been inspected. For both properties, project staff have been unable to find a telephone number for the property owners.

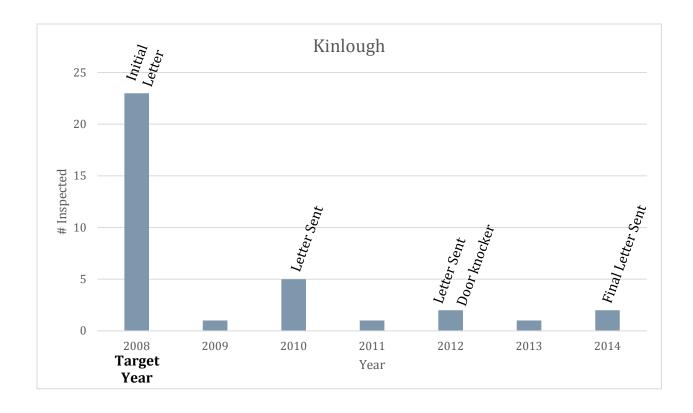
There was strong program participation following the initial letter sent in 2008. In the first year of inspections in Kinlough, 23 residents (or 64%) had inspections completed. A follow up letter in 2010, encouraged another 5 property owners to participate. Doorknocking and phone calls to property owners were required to get the remaining property owners, save one, to complete an inspection.

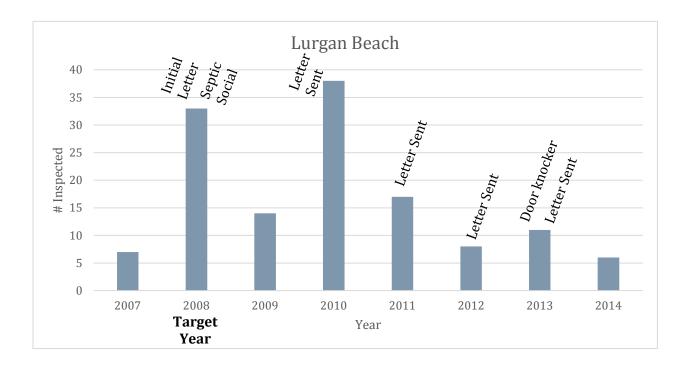
Similar to the Bruce Beach North target area, a number of property owners in Lurgan Beach participated in the program prior to receiving the initial letter. Between 2007 and 2009, during which the only contact was the initial letter, 54 properties owners had an inspection completed. In 2010, a reminder letter was sent and 38 property owners responded, 5 more than the number that booked an inspection following the initial letter. This suggests that more property owners in the area were hesitant to book inspections than in other target areas. This may be due to concerns about the inspection process and/or the condition of their systems. Another 10% of residents booked an appointment following another reminder letter in 2011. Doorknocking, additional letters and phone calling were required between 2012 and 2014 to encourage another 18% of property owners to participate in the program.

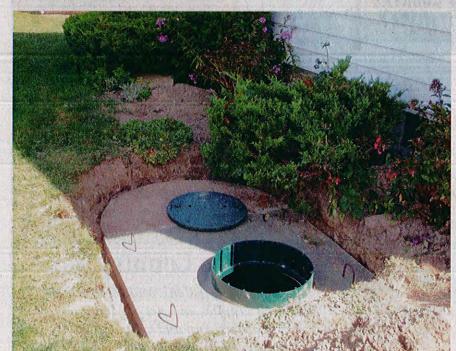
The Lake Huron shoreline, seen from the Point Clark lighthouse, (top) shows the close proximity of cottages and homes, and their septic systems, to the lake. Directly above, a new double chamber septic tank has risers to make it easy to access the tank for pumping and annual cleaning of the filter.
